## Skylights & Roof Rot

By Paul Malko, Mechanical Engineer

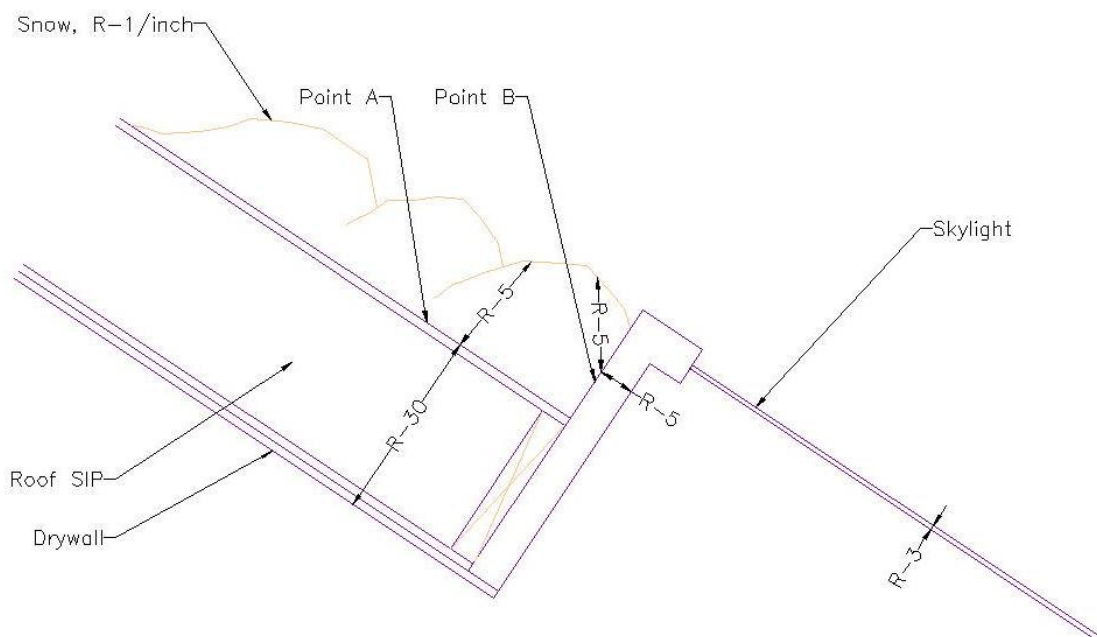
Figure 1: Vertical section through roof and curbed skylight

The figure shows a common “curbed” skylight. This curbing creates an un-pitched, or flat, valley above the skylight. It is this valley that causes most of the problems, water and snow does not readily to flow out of the valley.

This can be caused by improper installation and flashing, but many times the directions are followed properly and leaks still occur. The flashing technique used for SIP roofs is exactly the same as a stick built roof, the difference is in the stress applied to the flashing. Figure 1 shows a simplified skylight installation in a SIP roof.

Freeze thaw cycles, due to heat loss through the skylight curb assembly and the lack of heat loss through the adjacent roof. Adding crickets above skylights will reduce potential water infiltration and resulting rot.
